**Flood Control Project Maintenance
Levee Inspections**

Fall 2008 Levee Maintenance Deficiency Summary Report

San Joaquin River Basin

Reclamation District No. 2062

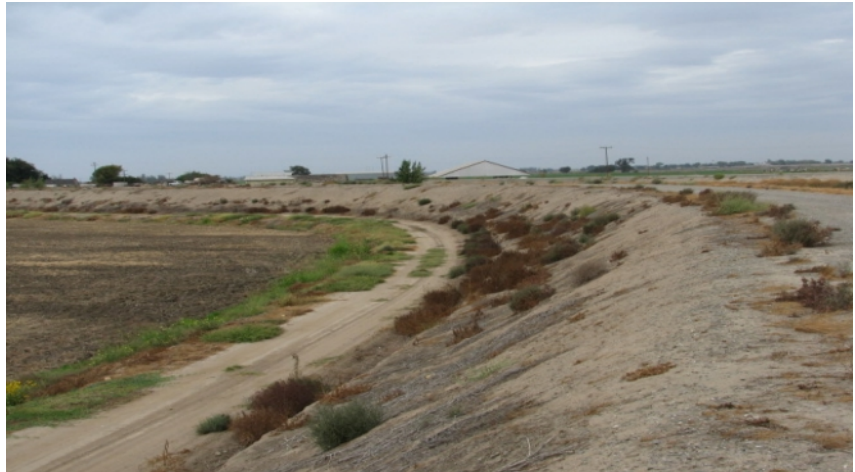
Levee Mile Report Line	1
Start Levee Mile	0.00
End Levee Mile	5.63
Location	
Category	Earthen Levee
Item	Vegetation
RD 2062 unit 3: Good conditions along entire unit LS.

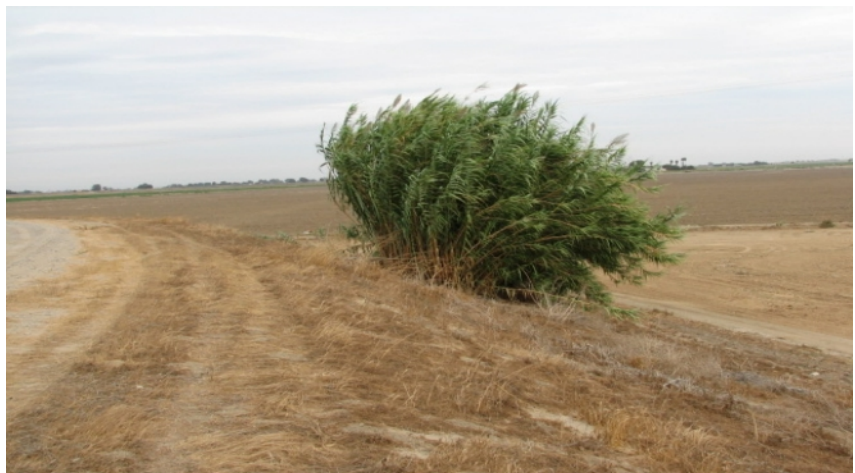
Levee Mile Report Line	6
Start Levee Mile	0.41
End Levee Mile	0.41
Location	
Category	Earthen Levee
Item	Vegetation
RD 2062: LS bush/tree that should be removed ASAP. This levee is in great condition, would not want this vegetation to spread.

6	0.41	0.41	Earthen Levee	Vegetation	LS	M	Remove the wild growth other than native grasses from the levee slopes.	37.810958 ° -121.383492 °	37.810958 ° -121.383492 °	Y	3
7	0.43	0.43	Earthen Levee	Vegetation	WS	M	Remove the wild growth other than native grasses from the levee slopes.	37.811405 ° -121.383222 °	37.811405 ° -121.383222 °	Y	6
8	0.56	0.56	Boat Survey	Boat Survey Erosion	WS	U	Inspector Comments: Inside a bend; 5 ft. into levee prism	37.813070 ° -121.383100 °	°	°	921
9	1.42	1.42	Boat Survey	Boat Survey Erosion	WS	M	Inspector Comments: Portion of rip rap collapsing; on the outside bend	37.821380 ° -121.376900 °	°	°	919

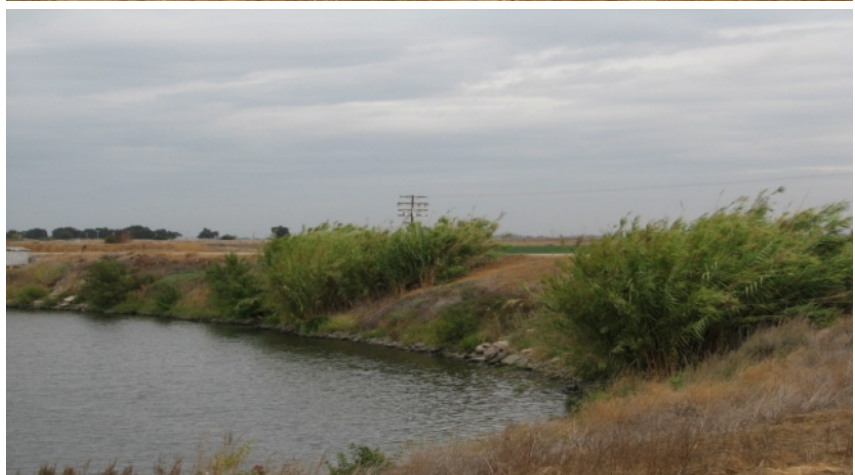
Levee Mile Report Line	7
Start Levee Mile	0.43
End Levee Mile	0.43
Location	
Category	Earthen Levee
Item	Vegetation
RD 2062: WS is beginning to develop unwanted vegetation. Remove ASAP.
